RE: SETTING A PUBLIC HEARING IN CONNECTION WITH THE ESTABLISHMENT OF ZONE OF ASSESSMENT "032" IN THE DUTCHESS COUNTY WATER DISTRICT LOCATED IN THE TOWN OF HYDE PARK

Pinebrook Expansion Water System (County District Zone of Assessment "032")

Engineer's Report - Pinebrook Water District Evaluation, prepared by Tighe & Bond, last revised August 2014

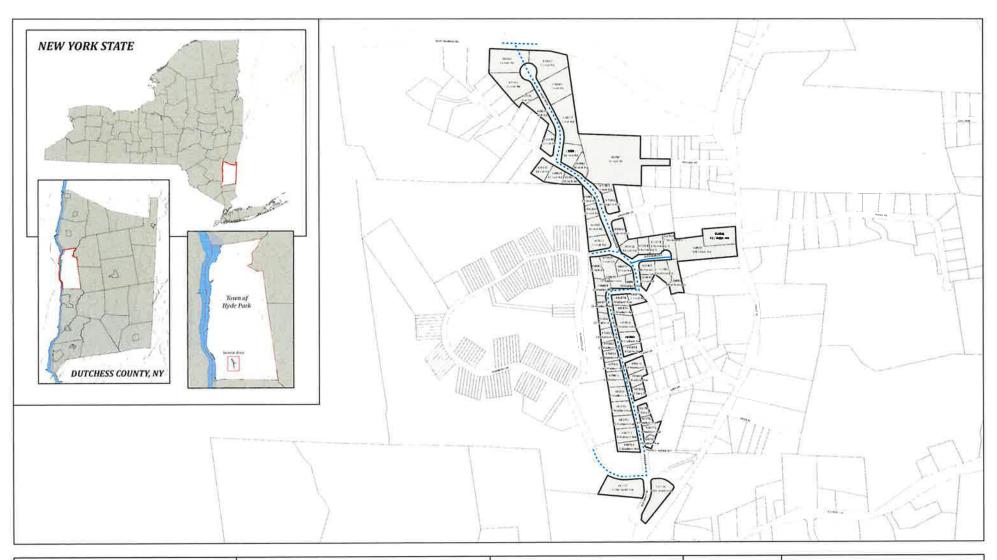
Pinebrook Expansion Water Hyde Park, NY **Dutchess County Water District** Zone of Assessment

DISCLAIMER: pipeline shown for discussion purposes, but field verification is required to determine location of pipe in street.

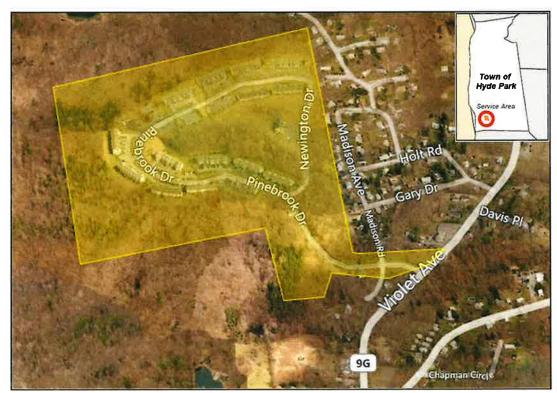
Figure 1-1 Pinebrook Water District

The Pinebrook Water District (District) is located in the southwest corner of the Town of Hyde Park, NY, as shown in Figure 1-1 below. The District serves approximately 132 residential connections located along Pinebrook Drive and Newington Drive in the Pinebrook Estates condominium development.

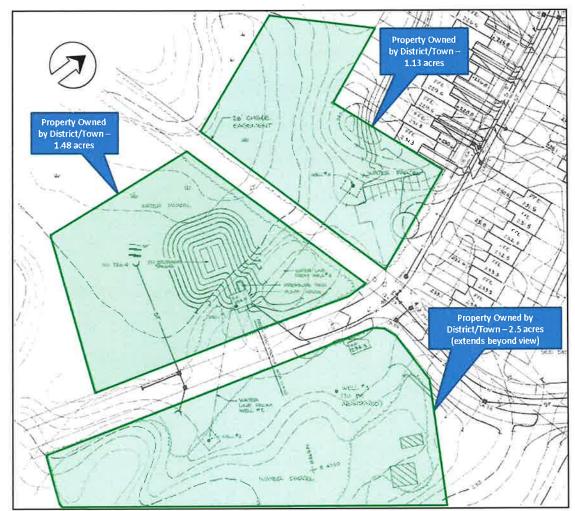
Figure 2-5 Pinebrook Water District Ownership

The treatment facility is located on a 1.48 acre site owned by the Water District/Town of Hyde Park, as shown in Figure 2-5 below. The two remote wells (Well Nos. 2 and 3) are

also located on 2.5 acre and 1.13 acre parcels, respectively, that are owned by the Water District/Town of Hyde Park. Based on our review of available documents, ownership does not appear to be a concern for the District.

Current DOH standards for water wells require ownership of a 100 foot radius surrounding public water supply wells. However, the regulations allow for exceptions of this rule if the wells were approved with less than a 100 foot radius prior to December 1, 2005. The ownership radius for Wells 1 and 2 meet and exceed this ownership requirement. Well 3 meets this requirement on three sides of the well, but does not meet the requirement on the North side, with less than 100 feet north of the well. It should also be noted that, per New York State regulations, all areas within a 200-foot radius of the wells require legally enforceable control by the water system.
